Manhole Inspection Summary

Manhole # S19G1_006MH

Insp Date: **4/29/08 1:51 PM**

Location Address: **2401 arbuton av**

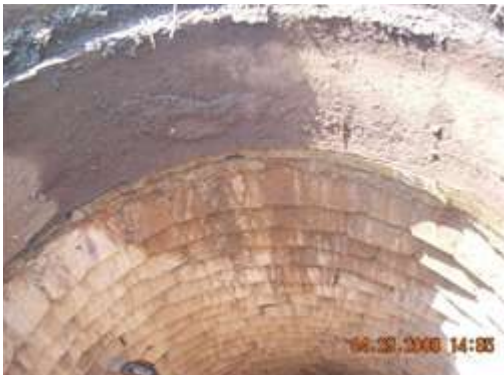
Defect 2

☒ **Leaks**

infiltration @ chimney/frame joint, Frame leaks-inflow evidence

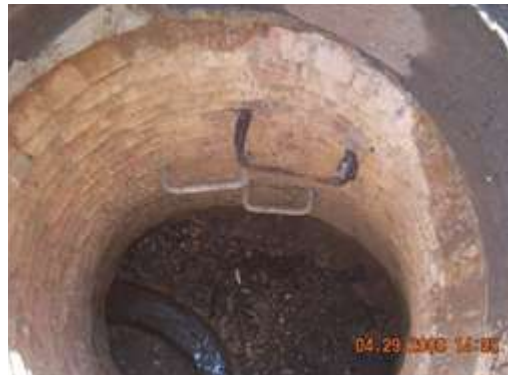
Defect 1

☒ **Debris**

☒ **Corroded**

corroded steps, bench debris

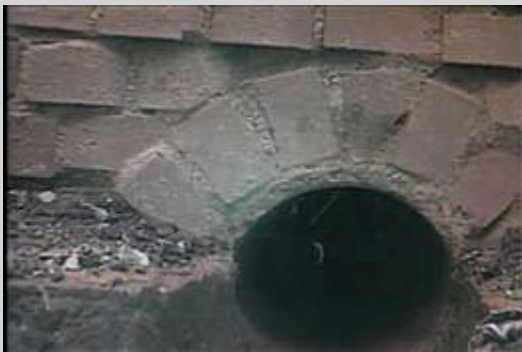
12 O'Clock Outflow

8 in. Circular Gravity Sewer
Pipe Out @ 12 O'Clock

Pipe Height: **8.4** (in.) Rod and Bar (Angled)
Pipe Material: **Clay** ☐ Pipe Lined
Invert Depth: **7.10** (ft.) Flow Characteristics: **Slow**
Deposits: ☒ None ☐ **Mud** ☐ Sludge ☐ Debris ☐ Grease
Silt Depth: **0** (in.) Deposits Extent:
Infiltration: **None** Pipe Seal Cond: **Sound**

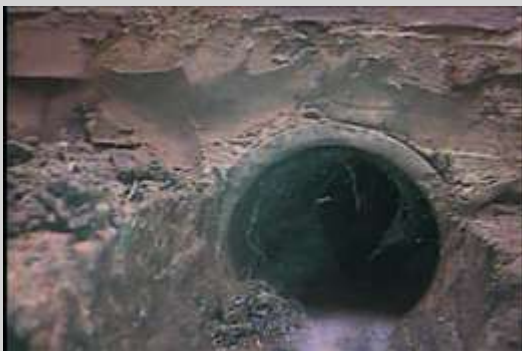
9 O'Clock Inflow

6 in. Circular Gravity Sewer
Pipe In @ 9 O'Clock

Pipe Height: **6** (in.) Rod and Bar (Angled)
Pipe Material: **Clay** ☐ Pipe Lined
Invert Depth: **6.72** (ft.) Flow Characteristics: **Slow**
Deposits: ☐ None ☒ **Mud** ☐ Sludge ☐ Debris ☐ Grease
Silt Depth: **1.5** (in.) Deposits Extent: **Light**
Infiltration: **None** Pipe Seal Cond: **Sound**
